DEPARTMENT OF NATURAL RESOURCES
DIVISION OF OIL, GAS AND MINING

SUBJECT: Site Inspection, U. S. Energy, Velvet Mine, M/037/040, San Juan County, Utah

Date of Inspection: August 8 and 19, 2003

M/037/040, Velvet Mine, U. S. Energy

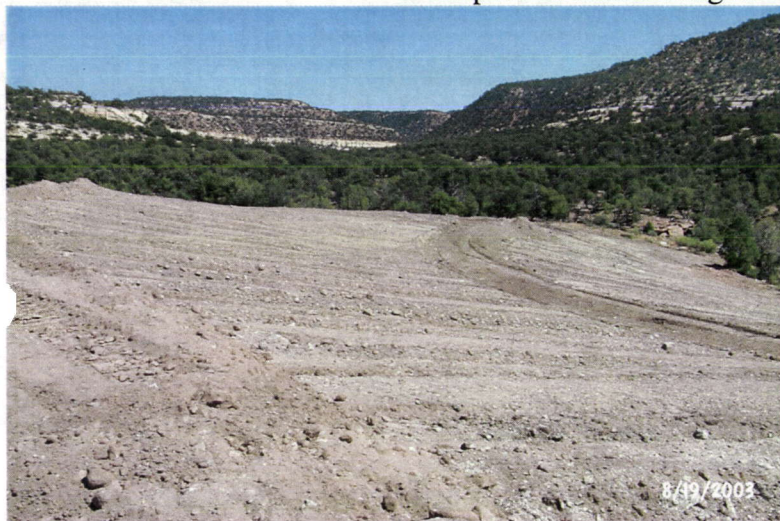
The site consists primarily of a pad made from waste material which has now been graded so the maximum slope is about 3h:1v. It is something of a convex slope, but the operator has created a berm at the edge of the flatter top portion of the pile. This berm should direct any runoff water to a natural drainage to the west. The upper terrace on the steeper portion of the outslope will direct runoff to the east, and the lower terrace will send it west. We believe this system of berms and terraces should help reduce runoff going straight down the slope and reduce the amount of erosion. Some of the berms are shown in Photos 1 and 2.

Photo 1. A portion of the regraded slope looking approximately east. Note the terraces or berms on the slope.

Right now, the surfaces are very smooth, and it is important that they be rough. Roughening should be done immediately before seeding so there is no chance for a surface crust to form on the soil. If the areas are ripped, the ripping should be done on the contour with ripper bars spaced no more than about three feet apart.

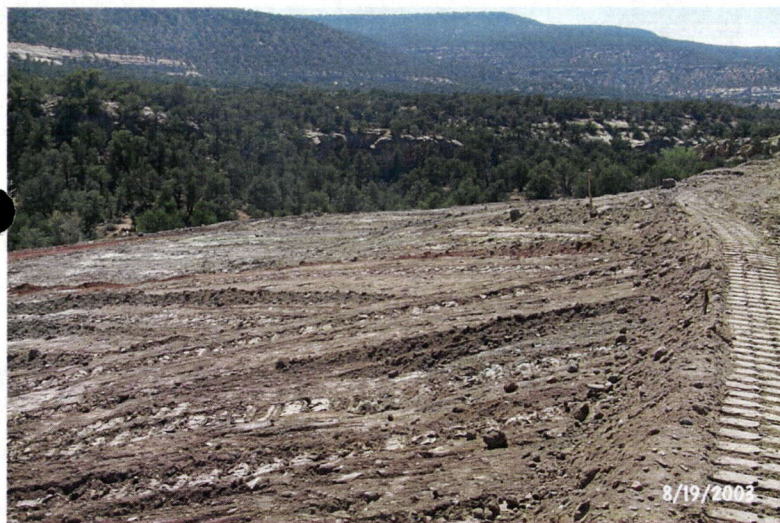
Photo 2. Another view of the regraded slope.

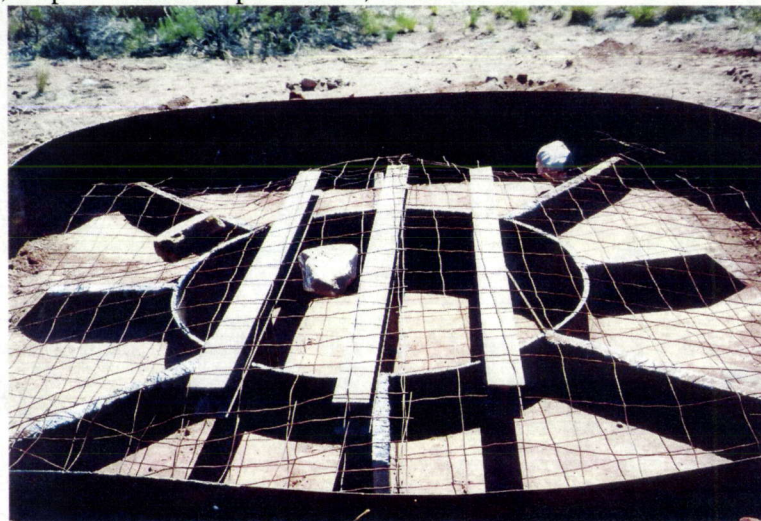
The water treatment pond has been backfilled and graded. The vent shafts have been sealed and covered with soil. Mr. Craft sent me pictures of the shafts after steel reinforcing material was placed on top of them and after the concrete was poured (Photos 3 and 4). All that is now visible at the shafts is mounds of dirt about 2-3 feet high.

Photo 3. Reinforcing material for one of the vent shafts. (Photo from Fred Craft.)

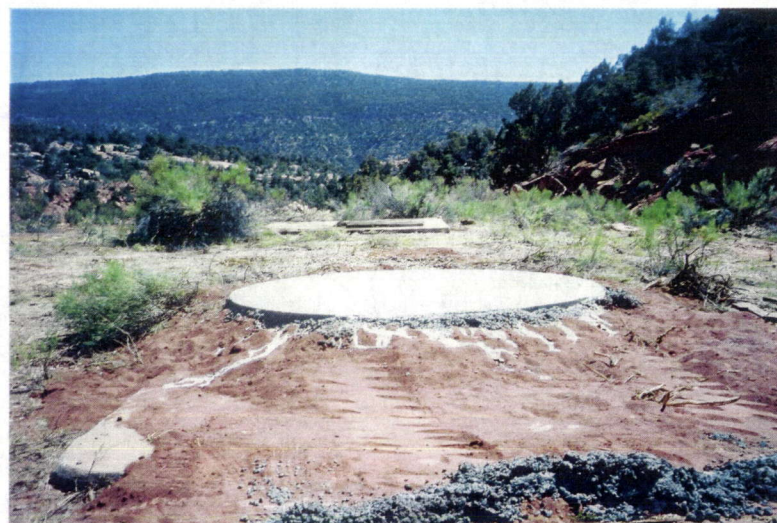
Photo 4. Vent shaft after the concrete cap was poured. This may have been where the headframe was. (Photo from Fred Craft.)
